www.mbsm.pro , when capacitor explodes , Pictures

Category: Pictures,Technologie,Tester ok
written by www.mbsm.pro | 29 December 2021

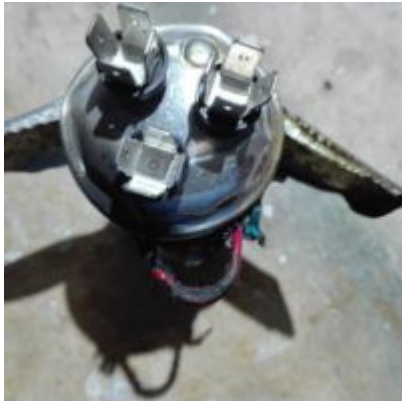
Unexpectedly the electrolytic capacitors explodes with huge sound and sometime it smoke.

You can now see how it is that an electrolytic capacitor fails, it is not a voltage breakdown of the dielectric material, but the increase of leakage current that is troublesome. A rising leakage means heat which will boil the water and make steam – that's the explosion process.

This is explosion as occasional failure of the few. But there is a more spectacular explosion process – it's explosion by mistake – namely being installed backward. In such a case, the anodizing chemistry is reversed and rather rapidly, the anodized film starts to reverse, and quickly thins out at a weak spot in the rather large effective film area of the capacitor. Then we have short circuit currents and steam generation rather quickly. This sort of explosion usually fills the space (the casing or the whole room if exposed) with little shreds of aluminum foil and alkali soaked paper.

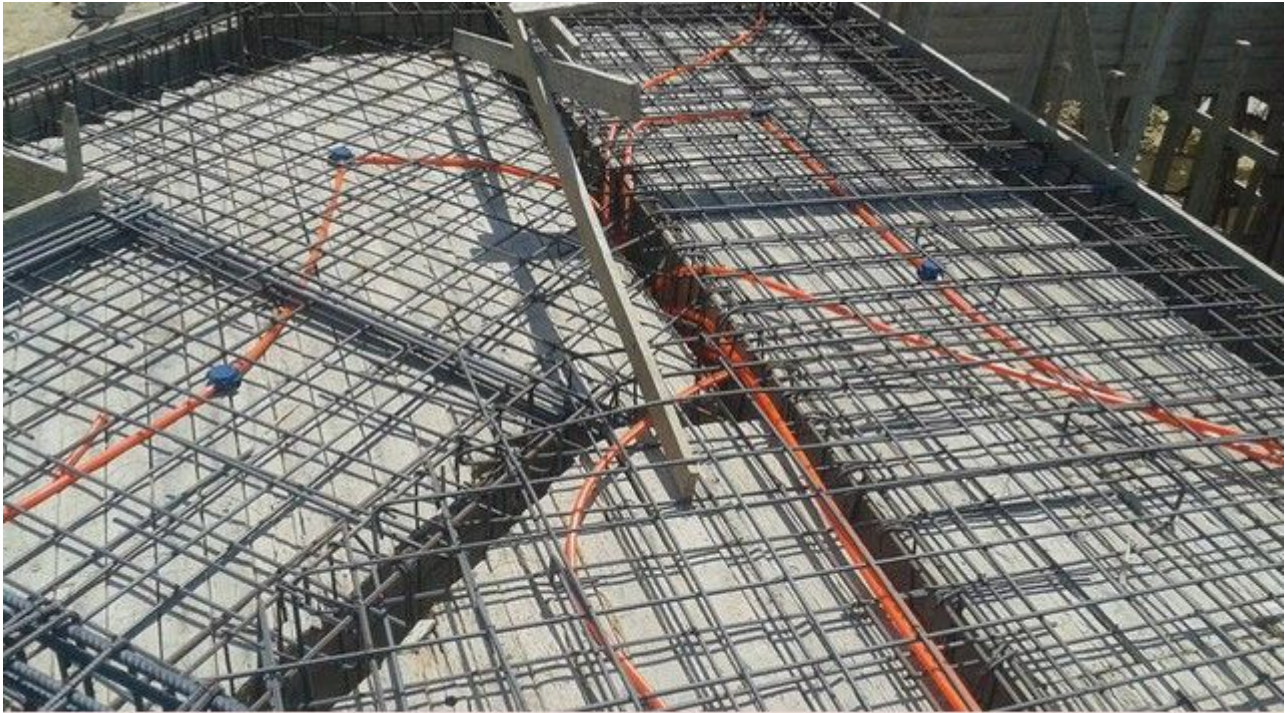
Mbsm.pro, The risk of extending the electric hoses under the reinforcing steel for ceilings
