Kulthorn, compressor, Kulthorn compressor, c-qn76l6f, c-qn76l6f-l, 1/10 Hp, 1Ph, Serie C-q, R134a, 76 watt, Low back pressure, 200-220V/50hz, 220v/60hz, Compressor modefier

Kulthorn, compressor, Kulthorn compressor, c-qn76l6f, 1/10 Hp, 1Ph, Serie C-q, R134a, 76 watt, Low back pressure, 200-220V/50hz, 220v/60hz, Compressor modefier Compressor Motor Protectors

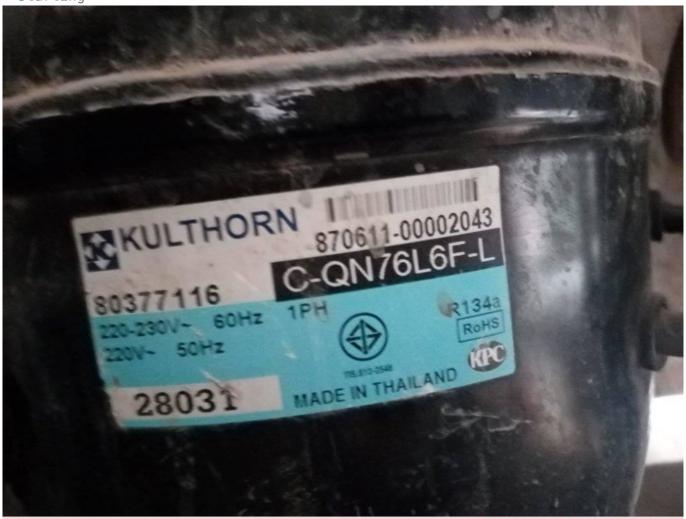
1. External Motor Protectors

A smaller compressor (such as an AZ, AE or WJ) is fitted with an external motor

protector. Most commonly, this is a compact, cylindrical device that contains a snapaction bimetallic disc. The protector is mounted in contact with the surface of the

compressor housing, inside the terminal guard.

The compressor current passes through the bimetallic disc. The resistance of this disc
