mbsm.pro , CUBIGEL Compressor GX21TB, 220-240 VOLTS, 5/8 HP , R134a

GX21TB VE01
220-240V 50Hz ~1

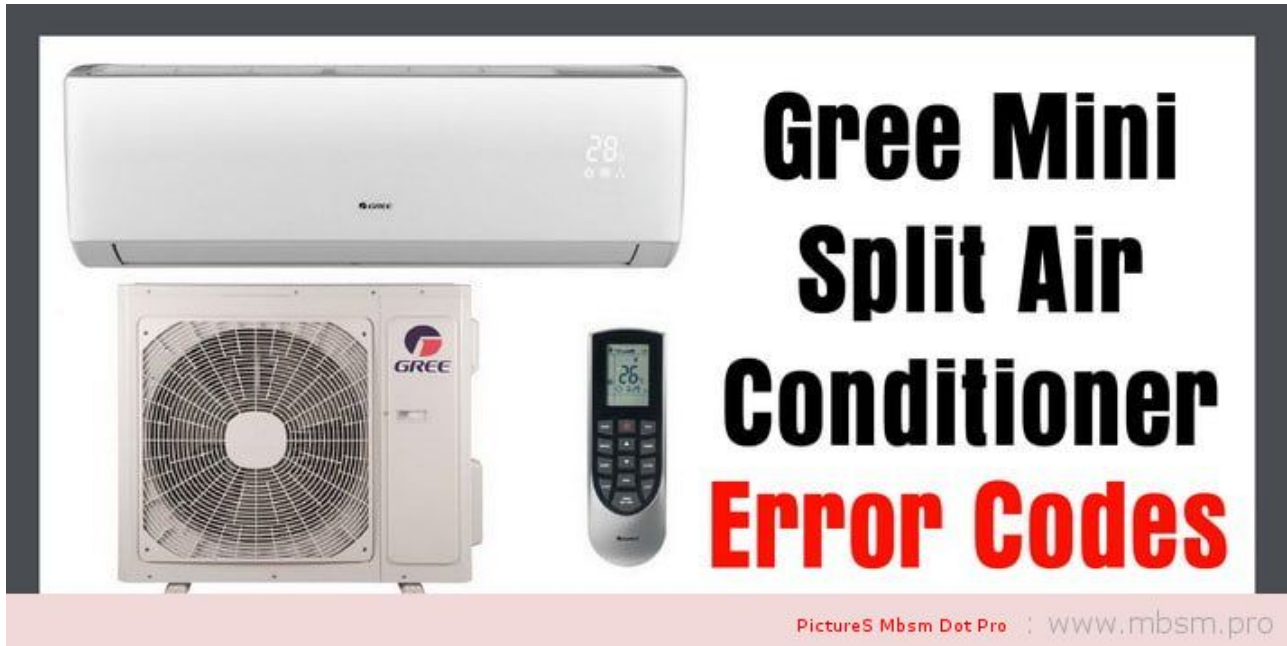
The error E6 comes from the engine, it is the electronic engine card if it is an inverter range.

Communication error E6 Between Outside and inside
